RELEASE NOTES
JN5189/QN9090/K32W061
ROM Patch Update V5

NXP Semiconductors

Document identifier: JN-AN-1263

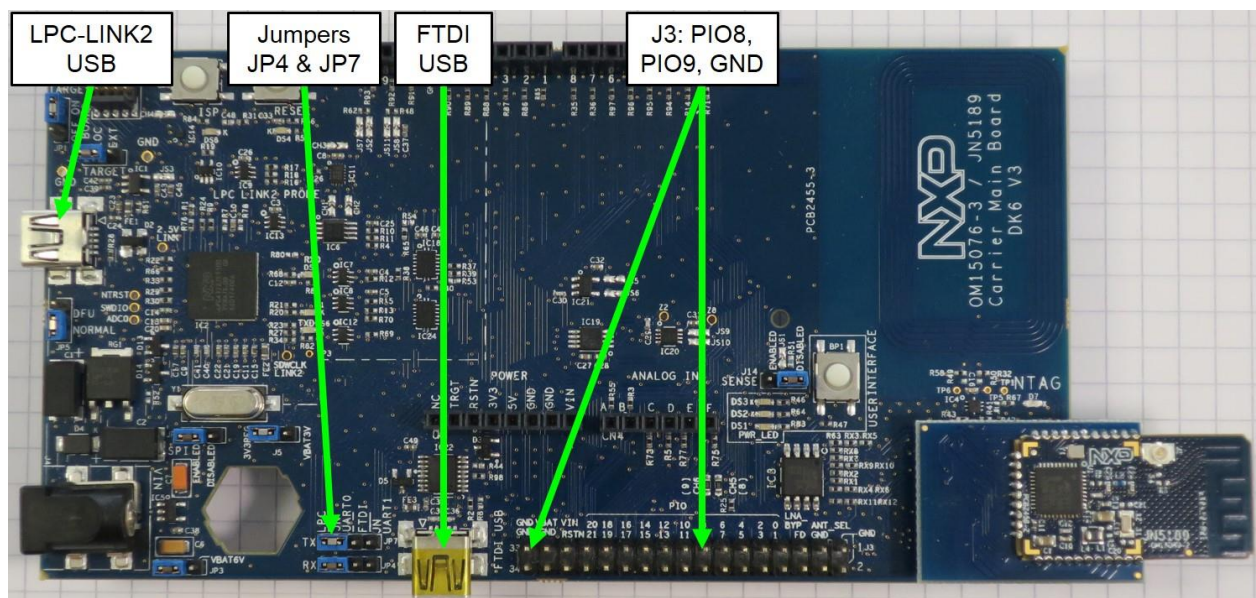
Flashing at 1M baud rate is supported, but not through the LPC-LINK2 USB connection. For example, when running the following command:

- If the COM port (COMx) used is connected to the LPC-LINK2, the command may fail to flash the binary
- If the COM port (COMx) used is connected to the FTDI USB or to a USB-UART serial converter connected to PIO8 & 9, the command shall always succeed

The picture below shows the various connection options for UART0 on the DK6 carrier board. The table beneath summarizes the baud rates supported on the connectors.

UART connection	1M baud rate support?	Comments
LPC-LINK2 USB connector	No	In this configuration the jumpers JP4 & JP7 (close to the FTDI USB connection) shall be in the leftmost position as shown in the picture above
FTDI USB connector	Yes	In this configuration the jumpers JP4 & JP7 (close to the FTDI USB connection) shall be in the middle , as shown here:

J3 debug connector (PIO8 & PIO9)	Yes	Use USB to UART serial converter supporting rates up to 1M. For instance, the Prolific USB-to-Serial converter is supported. It is available at: https://www.olimex.com/Products/Components/Cables/USB-Serial-Cable/USB-Serial-Cable-F/
